MILLSBORO POND DAM

DE 00018

PHASE 1 INSPECTION REPORT NATIONAL DAM SAFETY PROGRAM

Prepared by:
O'BRIEN & GERE ENGINEERS, INC.
JUSTIN & COURTNEY DIVISION

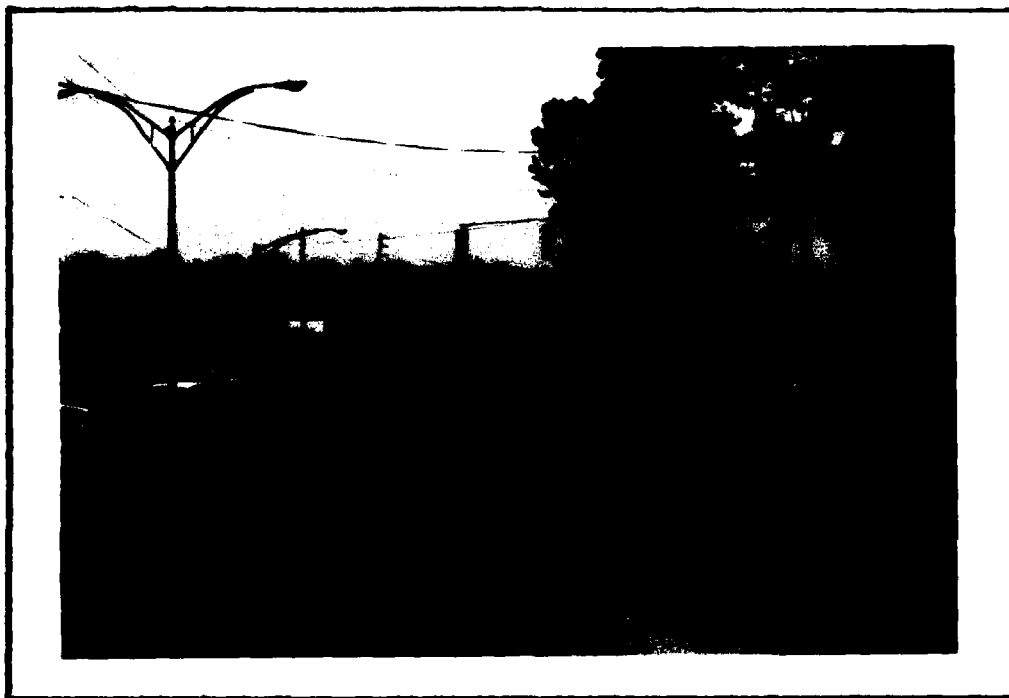
HIGHWAY ACROSS TOP OF EMBANKMENT
9-27-79

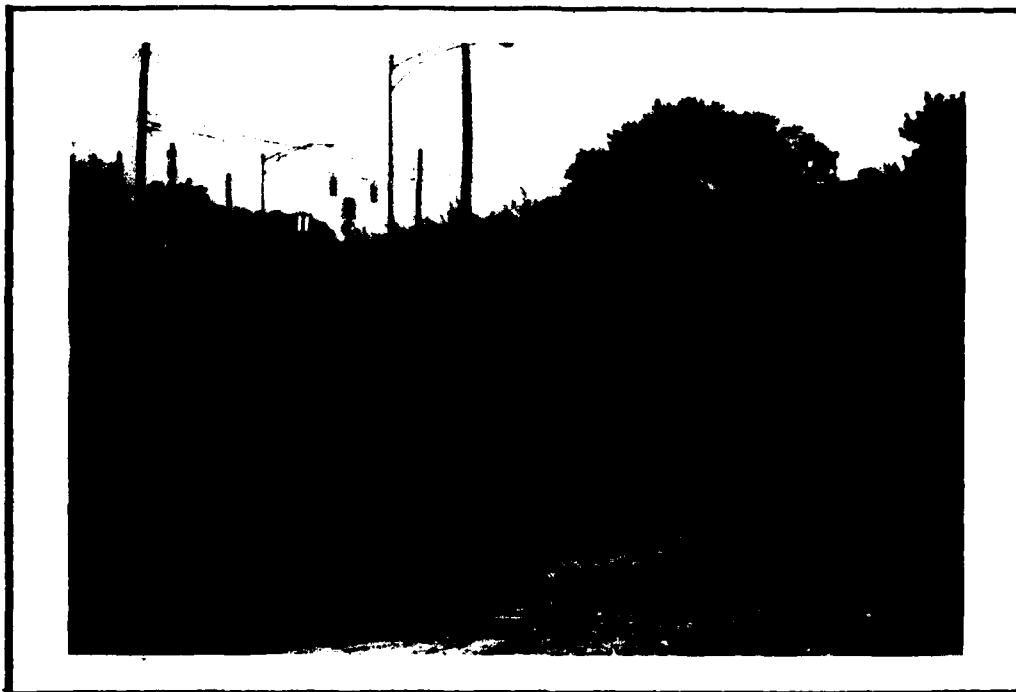
ERODED UPSTREAM SLOPE
TO LEFT OF SPILLWAY SECTION
9-27-79

3. Riprap should be placed on the upstream slope from the drawdown level (Elev. 0.75) to the top of the dam to protect against erosion.

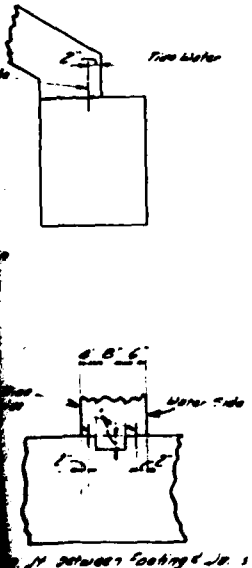
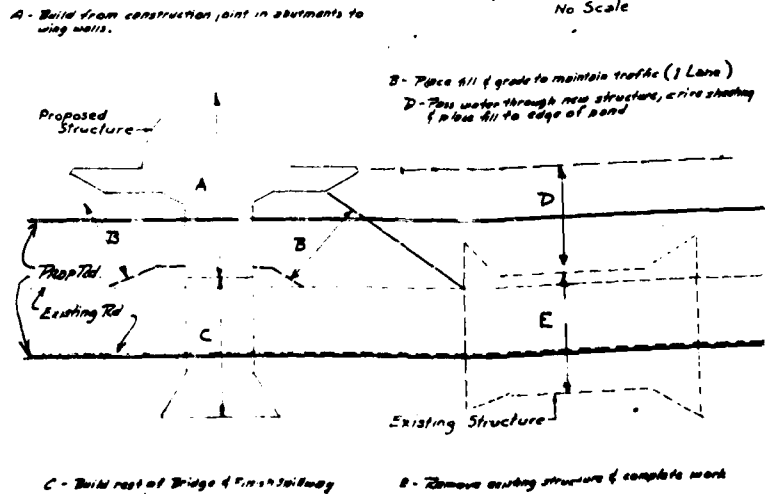
FIGURE 5

SUGGESTED CONSTRUCTION SEQUENCE
